## The Restoration of a Petter M

### An Unending Story

#### Part 1

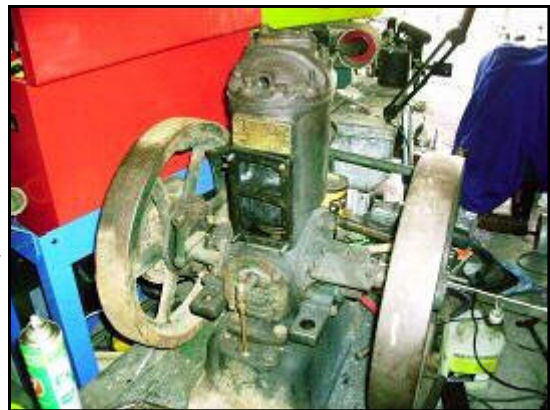
The engine was complete but John informed me that it had not been used for many years and had a broken fuel nozzle. The outside of the engine had a large amount of surface rust and bolts and nuts quite corroded.

nozzle was removed and after discussion with technical advisor Peter Daw, it was decided that we would leave this repair till later.

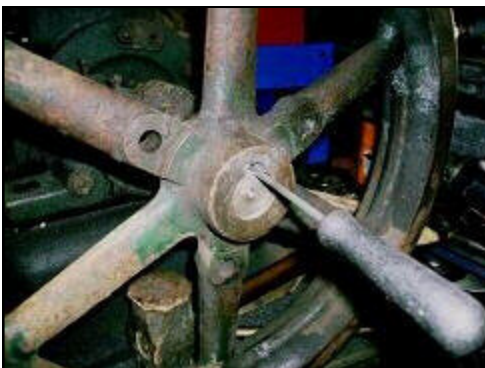
On closer examination a surplus driving sprocket on the inner side of the flywheel seemed to be facing up to the flywheel. Careful probing with a steel rule seemed to indicate that the gib key projected into the sprocket. A stronger pair of reading glasses indicated a broken grub screw in

the sprocket. Two hours of very careful cutting with an angle grinder released the sprocket with only a tiny nick in the shaft. More disappointment. The offending key only projected into sprocket by a couple of millimetres and was not being held by the grub screw. More heat and wedging and then the inevitable. The head came off the key.

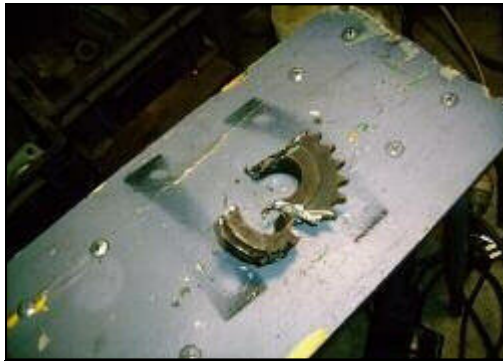
Remains of key

The only alternative was to drill the key out. This entailed a ¼" hole 2 ½" deep using a hand held drill which hopefully does enter the shaft or the flywheel. The first ½" was easy and only took a few minutes. Resharpen the drill, more lubricant and the progress was steady but extremely slow. When I estimated that we had about a quarter of an inch to go I could hear the voice of my long departed apprentice instructor, Mr Hudd, urging me to back off the pressure in case the drill broke as it came through. I didn't pay attention forty five years ago and things probably haven't changed that much, so thirty seconds later there was the distinctive sound of the drill breaking. Now I have a hard piece of tool steel 2" down an almost blind hole. Grinding up an old thin screw driver into a "u" shaped flat punch the broken bit was driven back out of the hole. A new drill bit with more care and the hole was finally through. Using a variety of tungsten blades, ground down hacksaw blades and needle files, enough of the key was removed to enable it to be tapped out. The cutting and filing took two days. Removal of the key from the second flywheel was achieved in two minutes and two bumps from the slide hammer. An hour and a half later the engine was completely dismantled. The engine appears to be restorable with the main problem being a worn big end bearing and the broken fuel nozzle.
