Blackstone Engine No. 106883

Prospect Hill Museum, South Australia

It didn't go first time!

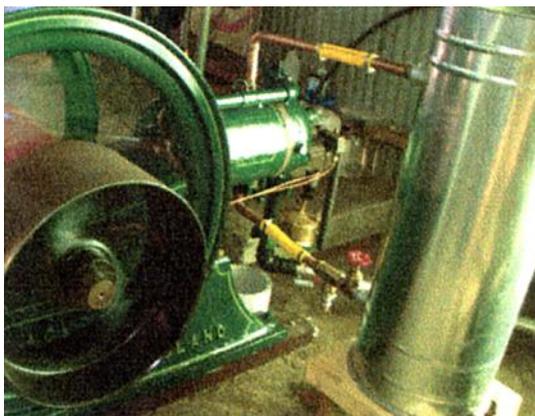
It took nearly 2 weeks and a lot of heat to get the top plug out, but the bottom one refused to budge, so I had to resort to a drill and a hacksaw blade. The removal of the plugs revealed, no bottom coil and a top coil full of gunk.

With the top coil cleaned up and a new bottom of coil of Termimesh, another attempt was made to start it, but this time there wasn't any smoke.
