## Restoration of a Wolseley WLB 8 Engine (or what can possibly go wrong now)

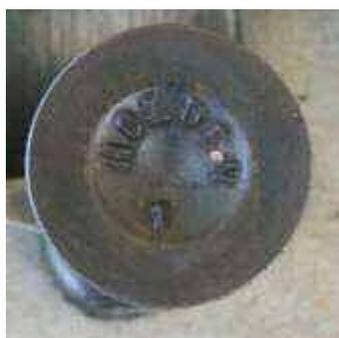
Time to clean up the valves on the 3.75HP unit! With the valve springs removed the inlet valve had excessive guide clearance. Further examination revealed "Holden" cast into valve head.

This was obviously an earlier repair and the engine must have run for a number of years with the replacement valve rattling in the guide. A second hand valve was obtained and the valves faced, lapped and installed in the block without any significant trouble.

Holden valve?

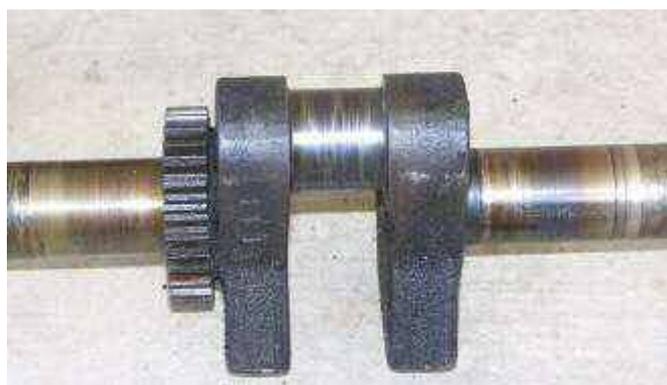
Removal of the side plate revealed the whole sorry story. The oil dipper had at some stage had broken off the connecting rod and the engine had obviously run without adequate lubrication. The litany of despair is as follows. 1/8" play in big end (hardly any shells left), big end housing on conrod scored due to "spun" shells, conrod black from heat and burnt oil, crankshaft big end journal badly scored, crankshaft main bearing journals blue from the heat and slight scoring of piston where it had nipped in the bore. Surprisingly the bronze main bearings appeared to be in very good condition.

Main bearing journals, blue with heat, bigend scored

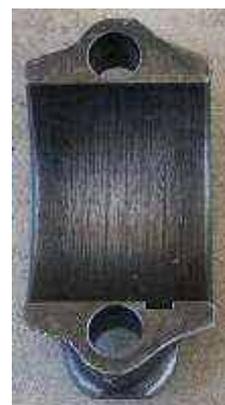
Damaged conrod cap
