RESTORATION OF GANE ENGINE

Firstly the name Gane, this came about as the engine came off a Gane milking machine. In fact it is a Ronaldson and Tippet two (2) horsepower straight petrol engine dated October 1939, engine number 15775.

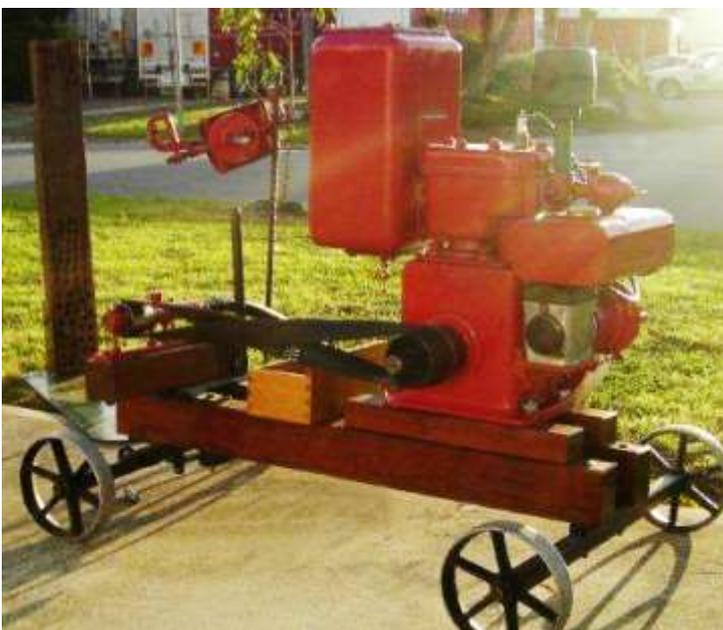
Gane engine with attached Post drill

The remainder of the job was fairly straight forward assembly and painting. Clean up the fence post drill, paint it, build a trolley and belt system to couple the two together. All complete but no fence post for drilling displays, so make a plate and bracket to hold a fence post. When I went to start the engine for the first time, I was just turning it over gently to make sure everything was working and it started.

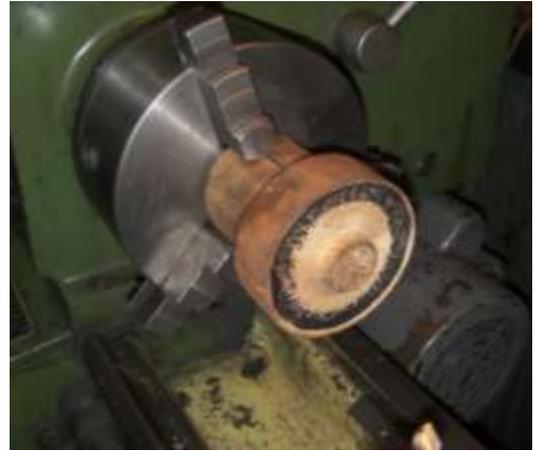
Demonstrates the machined ring sitting in the recessed wooden block in the lathe.

DO NOT glue the ends of the O ring as you can buy a special glue to do this. I then measured my piston for rings and went to Antique Motor Spares, John Biddle. He has several tea chests full of piston rings, all sizes, all shapes. After going through most of one tea chest I found 4 compression rings of the desired size. This was two for the top of the piston and one to make a ring, if I remember correctly $1/16''$ thick. This was to fit into the oil groove with the O ring as the groove was $3/16''$ wide and $1/8''$ deep, therefore I required a ring $1/16''$ wide. Now how do I reduce a $3/16''$ wide piston ring to $1/16''$. I put a block of wood into the lathe and bored a hole up the end of it to the diameter of the Gane engine bore, only bored about $1/4''$ deep.

I put the piston ring into this recess and started to face it off. It flew out of few times but did not break. I kept **this process going, removing the ring to measure it at regular intervals.** Eventually I had a $1/16''$ wide piston ring and I did not even require the fourth spare ring.

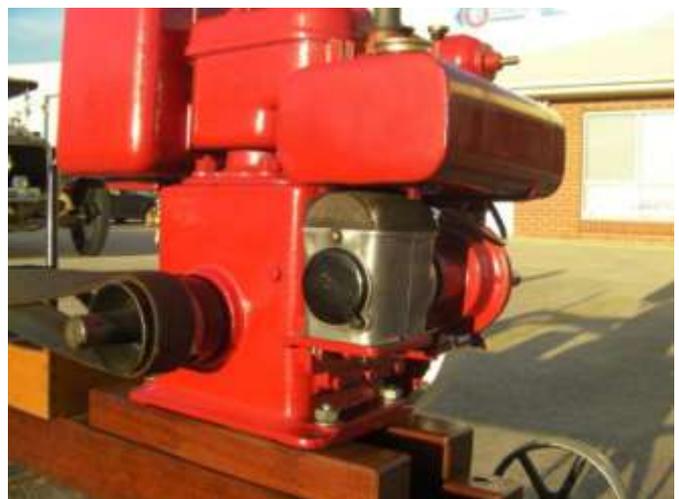
Gane engine showing the vertical mounted magneto

Something that has always intrigued me with this engine is the magneto is mounted up the right way as most Ronaldson and Tippett engines the magneto is mounted upside down. If anyone can explain why this is so I would appreciate a reply.
