Blackstone Engine No. 106883

Prospect Hill Museum, South Australia

It didn't go first time!

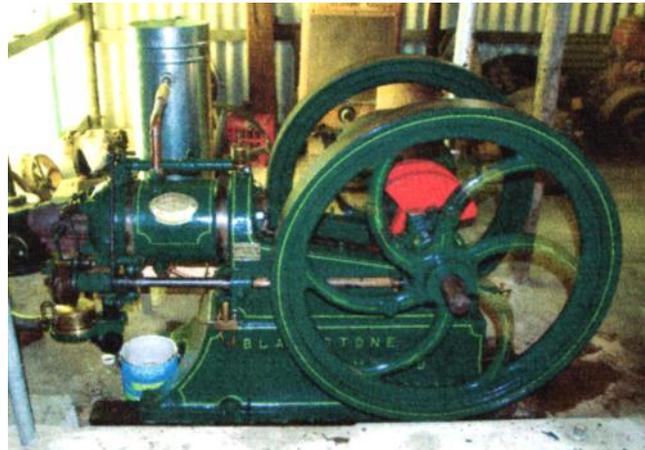
The accumulated dry grease was softened up with a degreaser before it was scrubbed with a rotary brass buff fitted to an angle grinder. Eventually the base had been scrubbed down along with the engine back to the flywheels. To finish the engine the flywheels had to be removed, so it was decided to paint the base, refit the engine, then remove the flywheels.

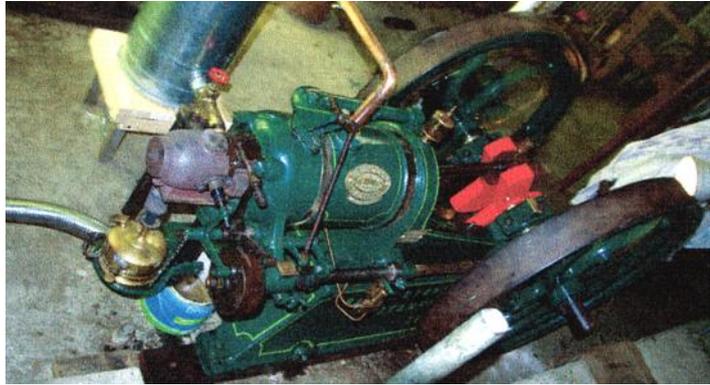
Cooling tank, Copper pipe and fittings for the fuel system, brass caps for the oil points and inspirator and vertical blowlamp. Whilst these were being put together the engine was pin striped.
