## Restoration of a Wolseley WLB 8 Engine (or what can possibly go wrong now)

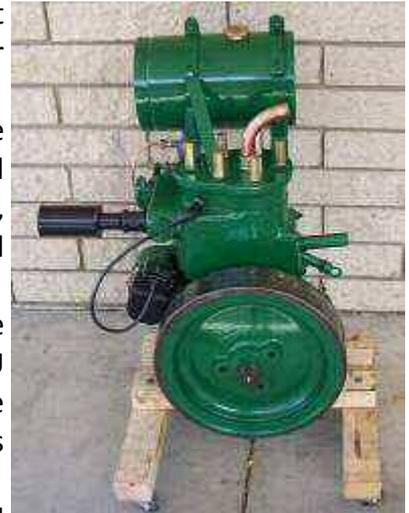
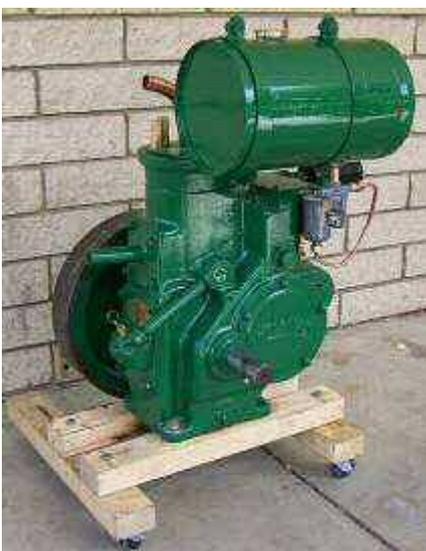
Removal of the side plate revealed the whole sorry story. The oil dipper had at some stage had broken off the connecting rod and the engine had obviously run without adequate lubrication. The litany of despair is as follows. 1/8" play in big end (hardly any shells left), big end housing on conrod scored due to "spun" shells, conrod black from heat and burnt oil, crankshaft big end journal badly scored, crankshaft main bearing journals blue from the heat and slight scoring of piston where it had nipped in the bore. Surprisingly the bronze main bearings appeared to be in very good condition.

Damaged conrod cap

I seriously considered loading the bits in the scrap bin but the stubborn streak in me took over and it decided to have a go. Repairing the shaft and big end was not really an option as the cost of obtaining oversize bearings and another conrod would have been prohibitive.

Although the flywheel on the replacement unit was badly out of alignment (cracked), the shaft, conrod and big end were true and in serviceable condition. The spare unit was externally badly corroded, so the flywheel removal took even longer this time. Eventually the parts were stripped and cleaned. On comparing the timing marks it became obvious that the original engine was a left hand rotation unit and the replacement parts were right hand rotation. The only solution was to replace all the rotating parts in the original unit.

Time to start replacing the rotating bits! The replacement crank was dressed and fitted into the crankcase. The camshaft was aligned and slid into place while holding the cam followers in place with my other two sets of hands.

With new rings obtained it was time to fit the old piston onto the new conrod. Problem! Despite what the book says, the gudgeon pins are a different size. Down to the local machine shop to have the conrod machined. The rings were fitted to the piston and the piston fitted to the bore. Tensioning the big end was interesting. While it doesn't indicate so in the book I suspect that the piston and conrod should probably be installed first as the
