# 2HP Witte Headless Stationary Engine

## The Restoration Project

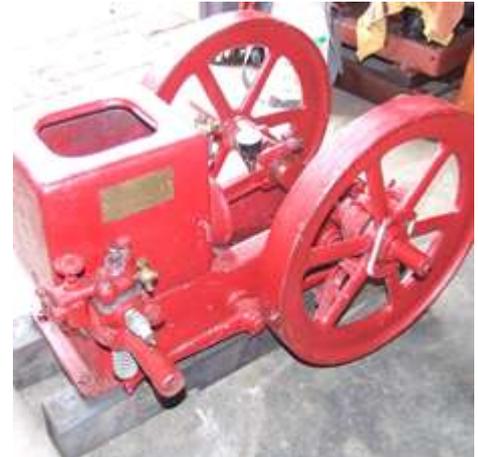
The photo below shows the parts of the engine, not much. There is no muffler, only a one inch pipe with a cap drilled with a lot of small holes. This is all they used after finding other Witte engines with the same on YouTube. The instruction book shows the same.

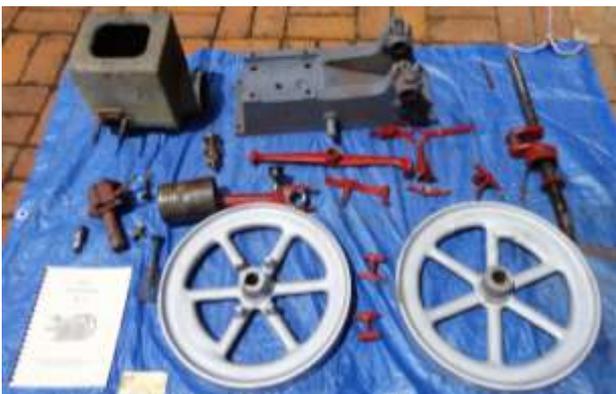
## Parts laid out less Cam Gear

The cylinder block was immersed in the electrolysis bath for two days to remove any other rust that the sandblasting could not get to. All the other engine parts that were painted were also put into the tank and cooked for about four hours each. There are parts missing and these included the cam gear, fuel tank, exciter coil (T Ford type) and a six volt battery. I was

able to find an instruction book on the net from the USA and this was purchased, well worth it. I was also able to source a second hand cam gear of unknown condition, but usable, so the seller informed me and new inlet and exhaust valve springs. Also able to find a fibre switching block and spring for the low tension wiring controls.

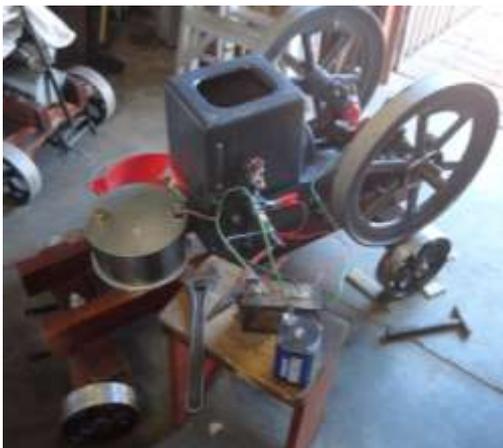
Trial run in shed  
The springs on the speed control for the hit and miss mechanism needed to be made as the ones

Picture left shows trial run setup.

On checking, the timing needed adjusting and a multi meter was used to check the firing timing. Tried again to run the engine but still not running satisfactory. I decided to replace the fuel non return valve on the carbie. A new copper fuel line and non return valve were made together with a new needle throttle valve in the carbie. Tried the engine once again and hey presto, it ran for about a minute OK till I turned it off.

which came with the engine were too heavy and would have the engine it running to fast. Joined two light springs together and the engine was fired up again and ran at 390 RPM. The box for the buzz coil and battery has been made with styrene packers to stop movement of the components and fitted to the transporter and wired up to a diagram emailed to me by Ben Wye.
