RESTORATION OF GANE ENGINE

Firstly the name Gane, this came about as the engine came off a Gane milking machine. In fact it is a Ronaldson and Tippet two (2) horsepower straight petrol engine dated October 1939, engine number 15775.

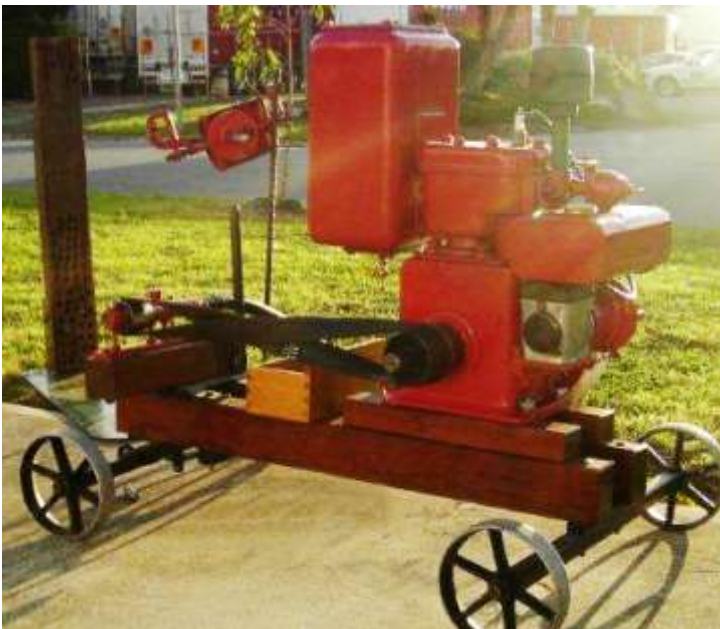
Gane engine with attached Post drill

The remainder of the job was fairly straight forward assembly and painting. Clean up the fence post drill, paint it, build a trolley and belt system to couple the two together. All complete but no fence post for drilling displays, so make a plate and bracket to hold a fence post. When I went to start the engine for the first time, I was just turning it over gently to make sure everything was working and it started.
